*Early Domestic Architecture  
of Connecticut*

*By J. Frederick Kelly*

J. Frederick Kelly, A.I.A.

New Haven: Yale University Press

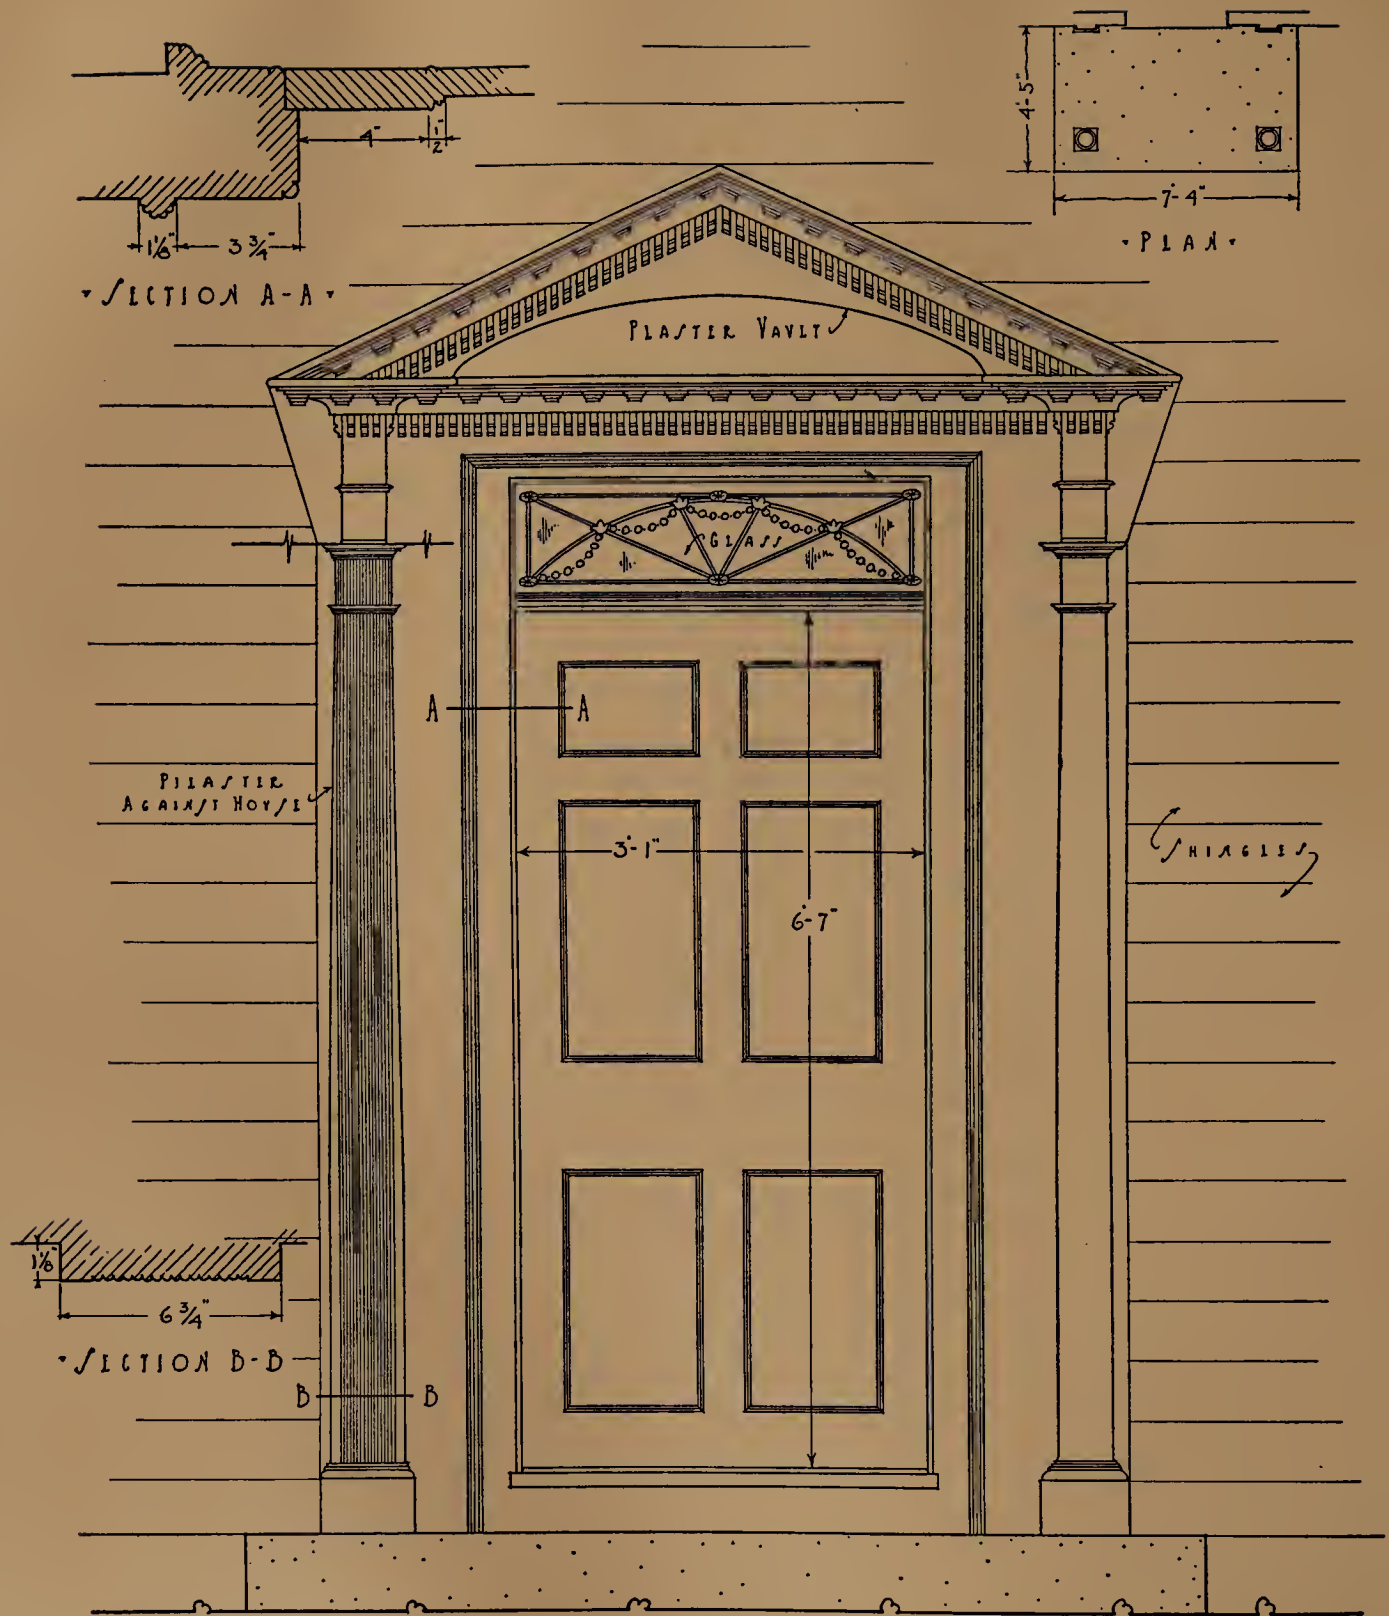
FIGURE 117.

FRONT ENTRANCE  
 HAWLEY HOUSE - MONROE

The second of our types, that in which the builder's originality was allowed freer scope and Classical lines were less closely followed, may be found embodied in the front entrance porch of the Cyrus Hawley house in Monroe (*circa* 1740). (Figure 117.)

The original columns of this porch are, very unfortunately, missing; an attempted restoration has been made in the drawing. Possibly the supports in this case were simply chamfered posts, with moulded caps and bases. The entablature is of great interest, in that it bears no relation to its stone antecedents save in its division into three main parts. Architrave, frieze, and cornice are all represented, but not in conventional form. Behind the columns, and against the house, are placed very flat pilasters, the vertical surfaces of which are finely beaded.

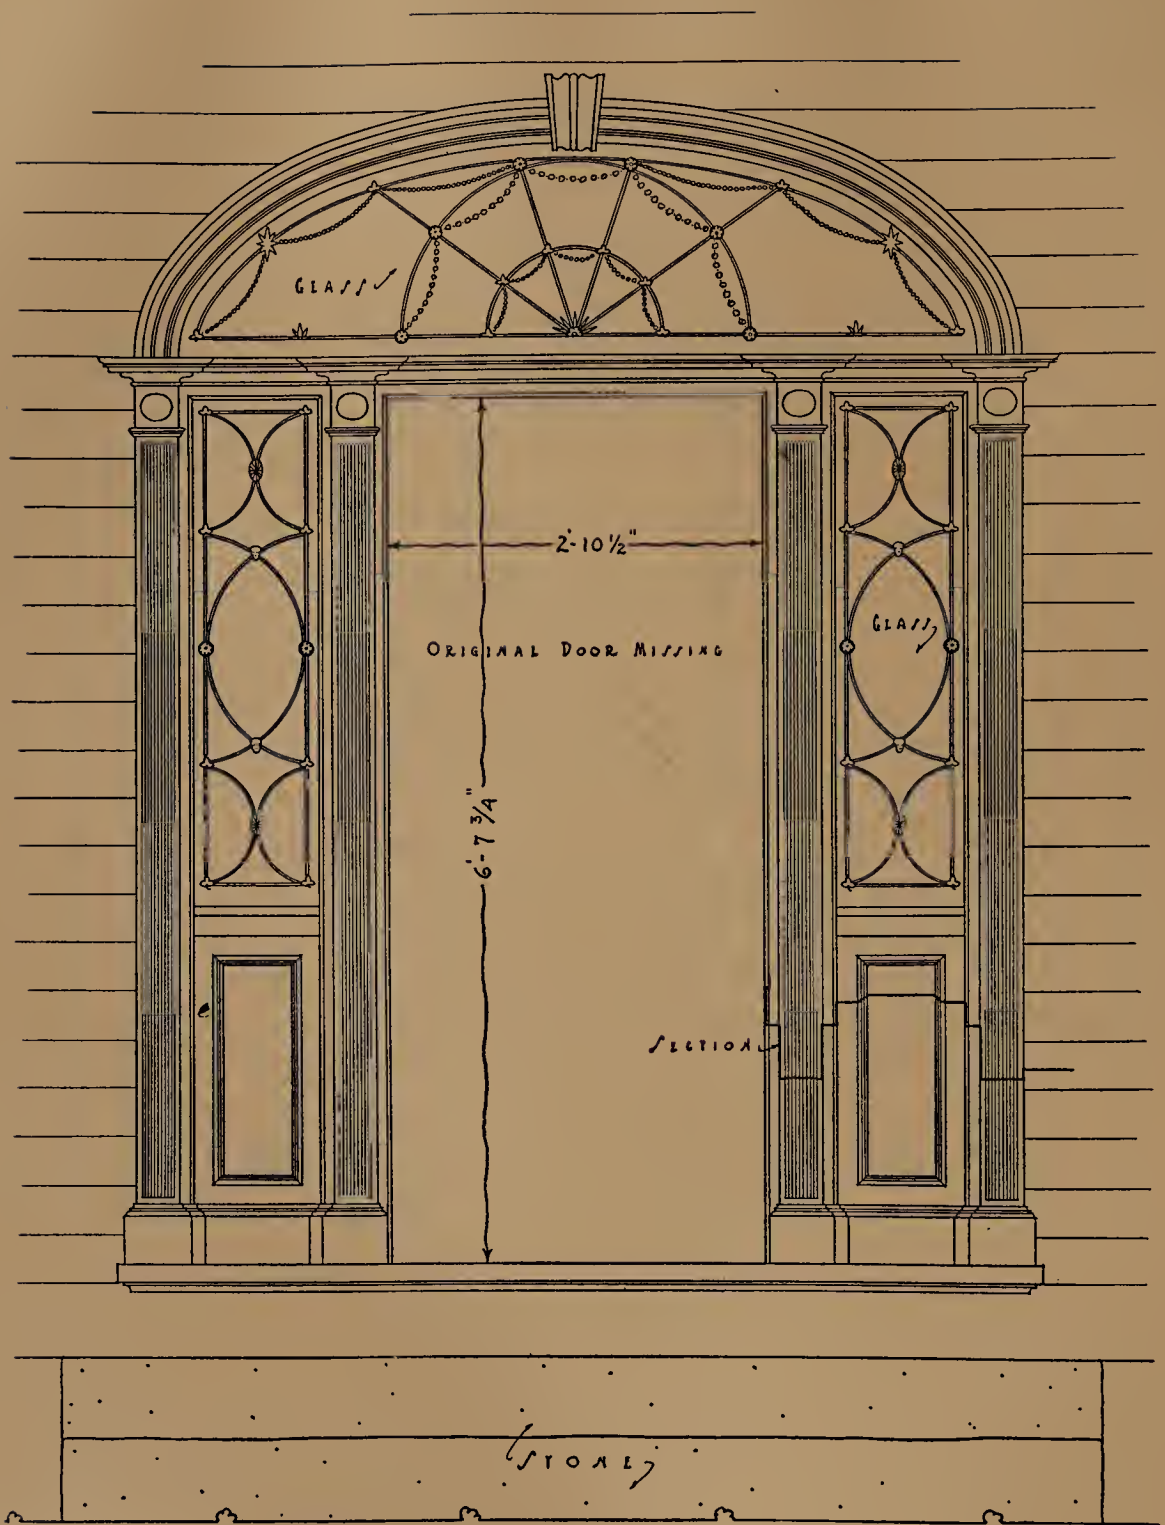
FIGURE 118.

• FRONT ENTRANCE •

✓ CORNWELL HOUSE - CHESHIRE ✓

of this sort are built into the house wall and do not project beyond it. The front entrance of the Cornwell house in Cheshire (*circa* 1820) is a typical example. (Figure 118.) The original door of this entrance is missing; but it is said to have been of the regular six-panelled type. The opening measures 3 feet 1 inch in width by 6 feet 8 inches in height. It is flanked by rectangular side-lights, 11½ inches wide, the tops of which line with that of the door opening. The sills of these side-lights are a little below the middle of the door, and the space beneath them is panelled. The door jambs, which form mullions between the door and each side-light, are treated somewhat as pilasters, the moulded transom bar being mitered to form their caps. The side-lights are filled with glass set in lead bars, the intersections of which, as in the transom, are covered with applied ornaments of cast lead. Door and side-lights are crowned by a large transom or fan-light of semielliptical shape, glazed in the same fashion as the side-lights. A handsomely moulded key block is set into the trim which frames it. In both the fan- and side-lights the glass is set flush with the exterior surface of the sash frames. A section showing this construction is shown in Figure 119. This appears to have been the typical manner of installing leaded glass.

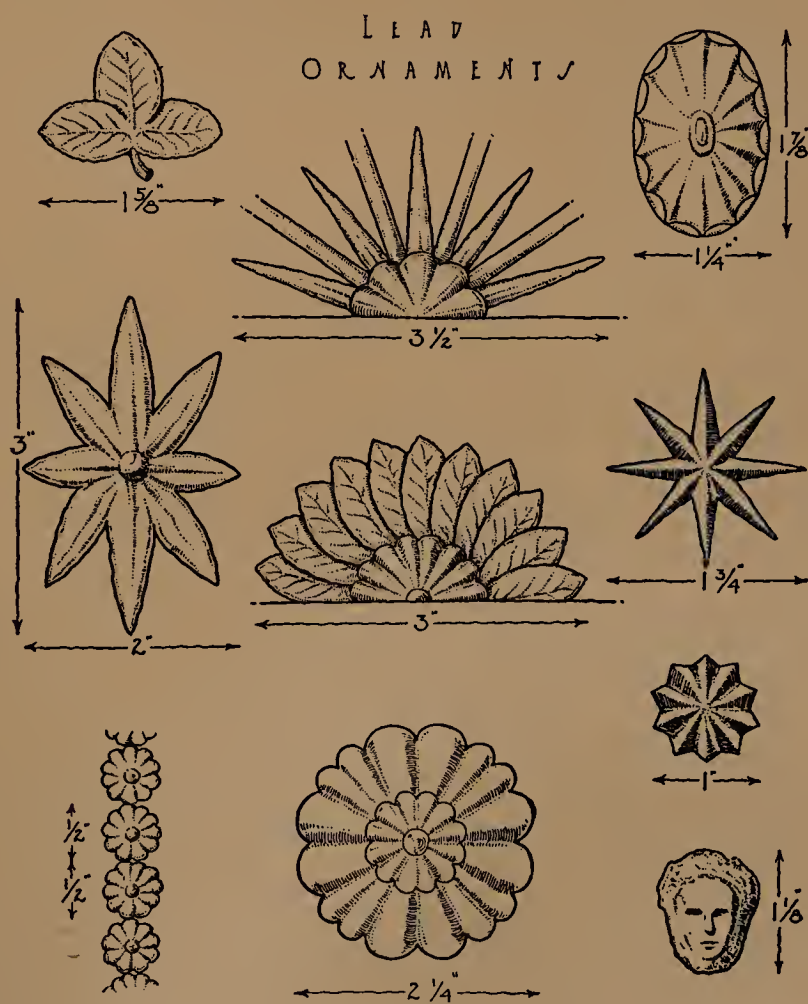
FIGURE 120.

Ornaments of cast lead such as were used to embellish the glass of this entrance are to be found in a great variety of forms and sizes. Various fruits, such as the blackberry and the pineapple, leaves of various form, human faces, and the more conventional rosette are all commonly met with, cleverly applied as spots of decoration to cover the intersec-

tions of the calmes or lead bars. (Figure 120.) In fan-lights, the lead bars of which radiate from a common center, there was customarily placed an ornament somewhat on the order of a sunburst, such as is shown in Figure 121. The lead eagle, shown in Figure 122, measuring nine inches from tip to tip of its wings, is an unusually fine specimen of the lead-worker's art. This ornament was taken from the transom over the doorway of an old house standing on Meadow Street, New Haven.

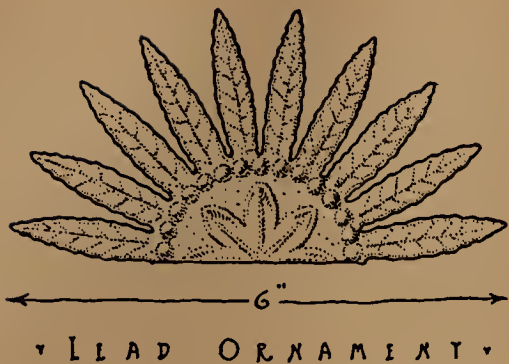
FIGURE 121.

ELY HOUSE - ELY'S LANDING

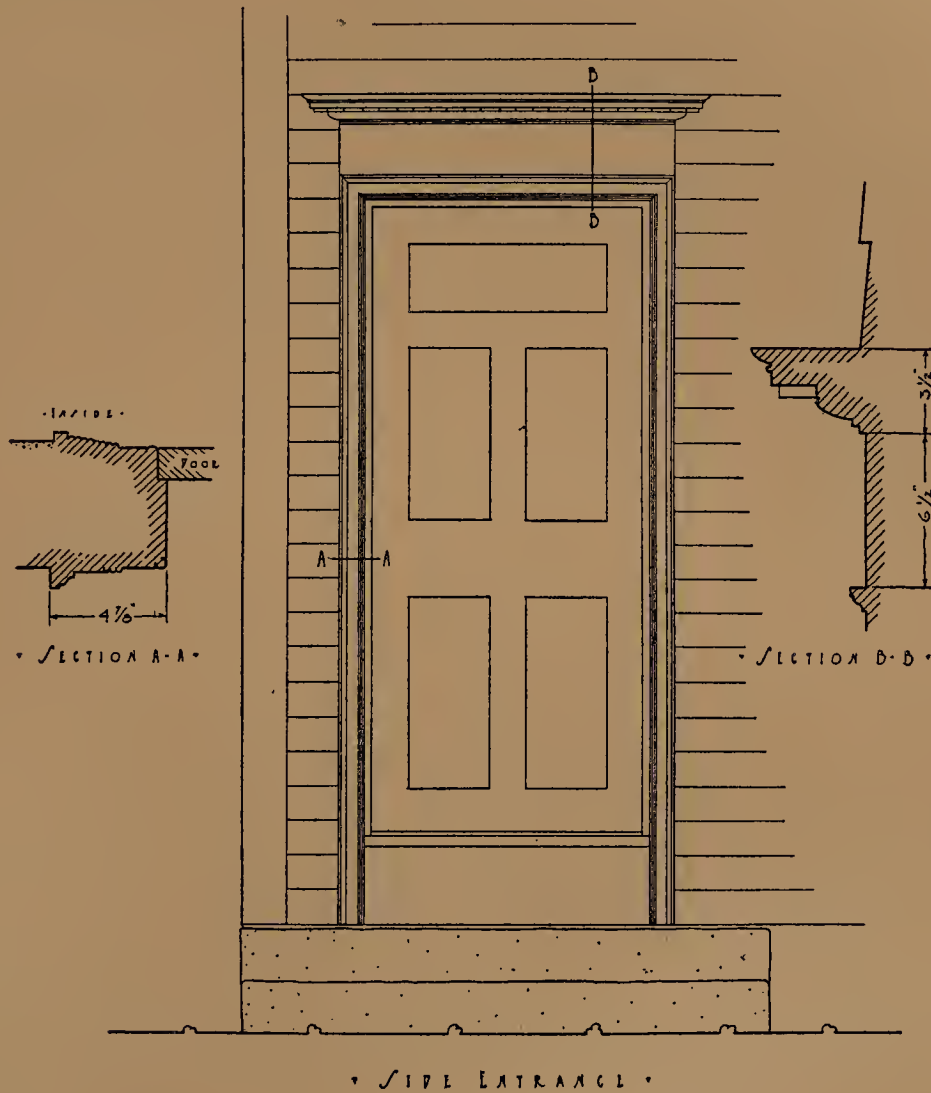
FIGURE 123.

• SIDE ENTRANCE •  
 / BARDER HOUSE - SIMSBURY /

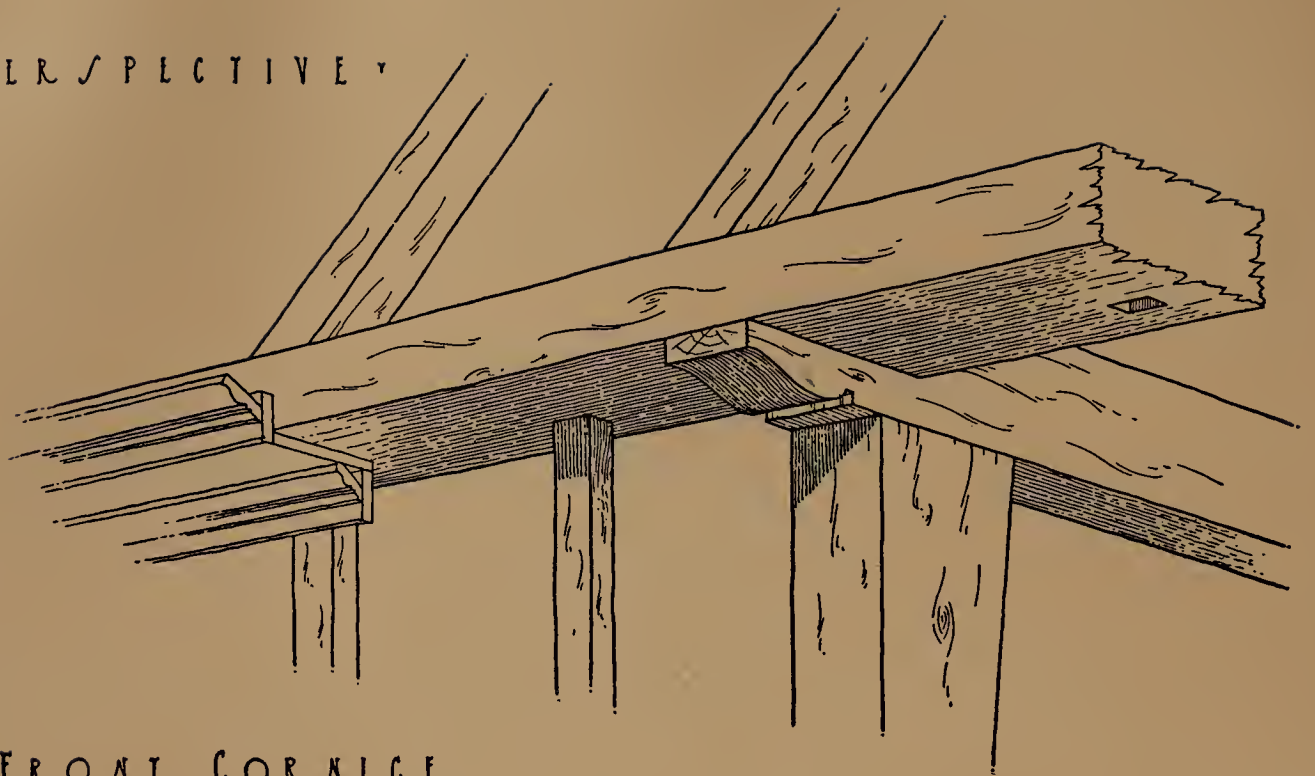
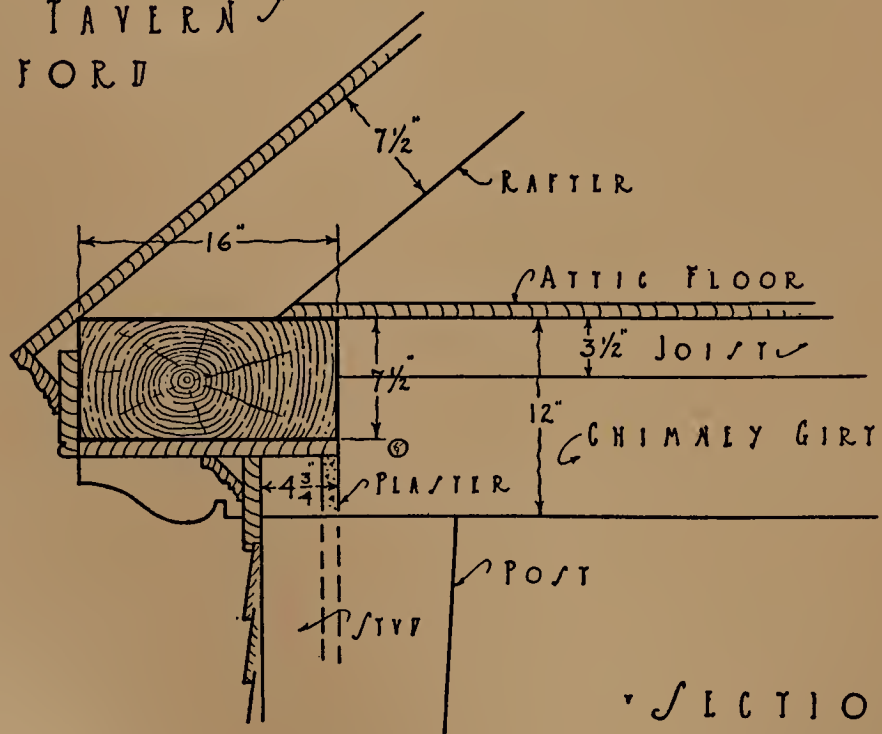
FIGURE 124.

✓ FRONT CORNICE  
✓ EVART'S TAVERN ✓  
NORTHFORD

Investigation of the earliest cornices which still exist indicated that they were formed in nearly every instance by framing the front plate in such a manner that its outer face extended beyond the house line below it. The front cornice of the old Evarts Tavern in Northford (*circa* 1710) is so built; and its construction is of extreme interest. From Figure 124 it will be seen that the greater part of the front plate, the width of which is more than twice its depth, extends beyond the front wall of the house, its back being flush with the inner sides of the studs. It is supported in this position by the cantilevered ends of the

four second-story girts, the projecting ends of which have been hewn into the form of brackets. The plate is cased with wood; so that, with the addition of crown and bed mouldings, a cornice of more or less Classical contour results.

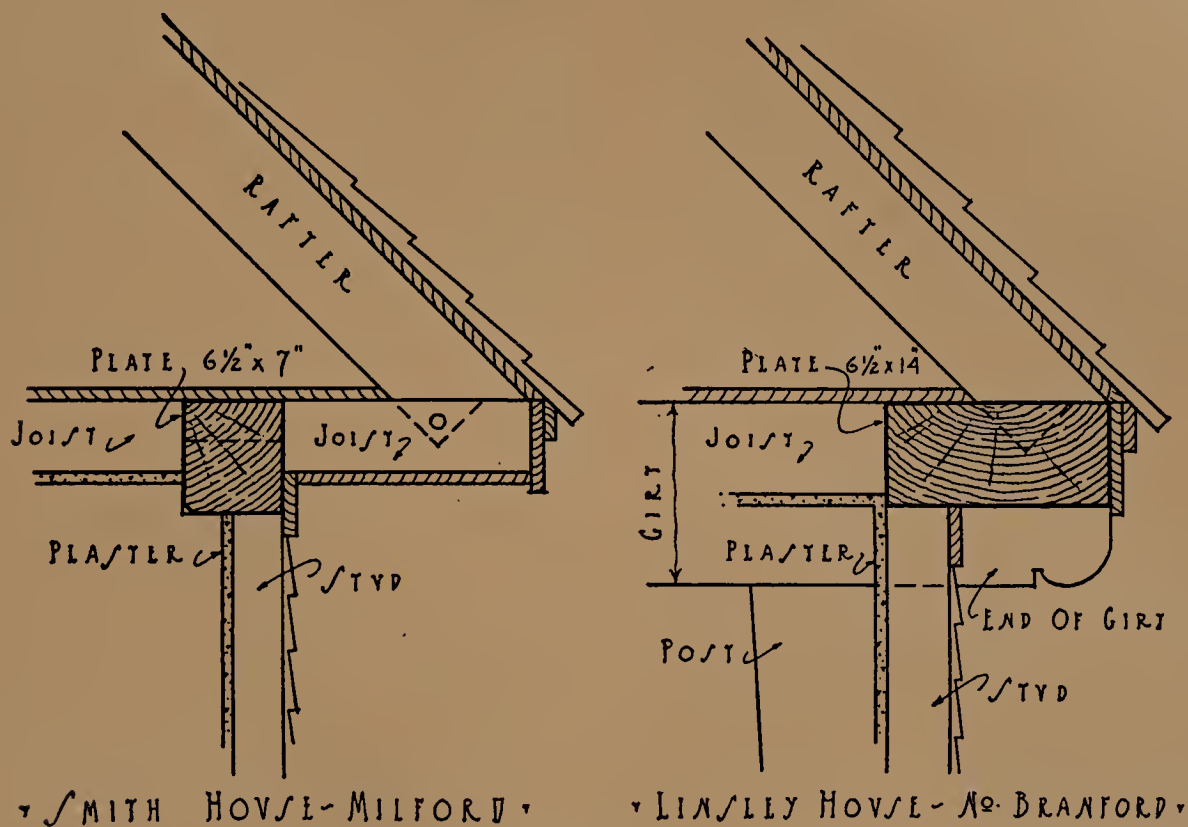
FIGURE 125.

The front cornice of the Linsley house in North Branford (*circa* 1700), shown in section in Figure 125, is quite similar in its construction. As the Evarts Tavern and the Linsley house are within a few miles of each other, it is possible that they are both the work of the same builder. As in the just preceding example, the front plate is extremely wide for its depth, and is projected beyond the house line so that it is flush with the backs of the studs on the inside. The ends of the four girts supporting it, which are cantilevered over the tops of the front posts, have been cut in the form of rather clumsy brackets. This plate is cased on the face, but not on the bottom, which is left exposed; mouldings are altogether

The cornice of the Smith house in Milford (*circa* 1690) is also a constructional one, as a section of its framing shows. (Figure 125.) In building this cornice, the principle of the cantilever was also resorted to; for, although the front plate occupies its accustomed place on the house line, the rafter feet, instead of resting on it, are supported by the projecting ends of the principal attic-floor joists. (See Figures 128 and 129.) These joists are

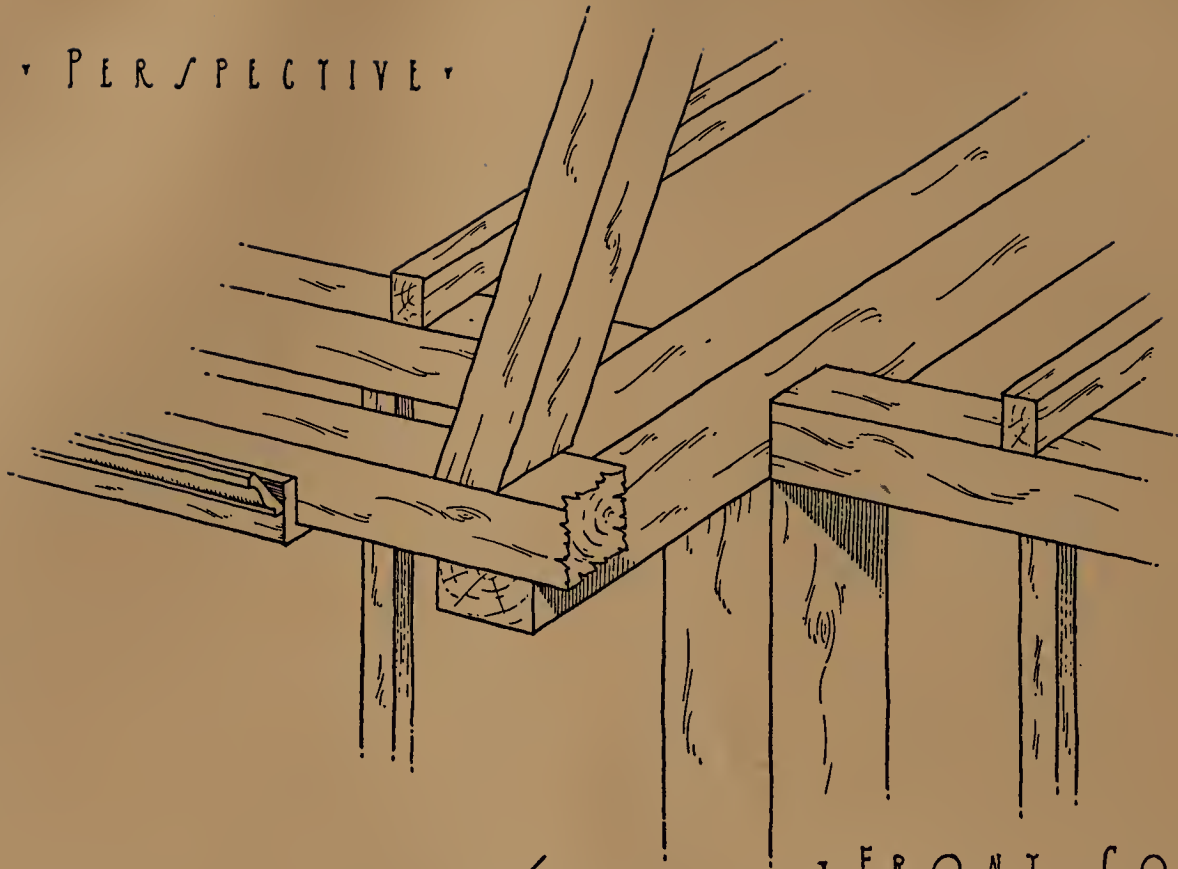
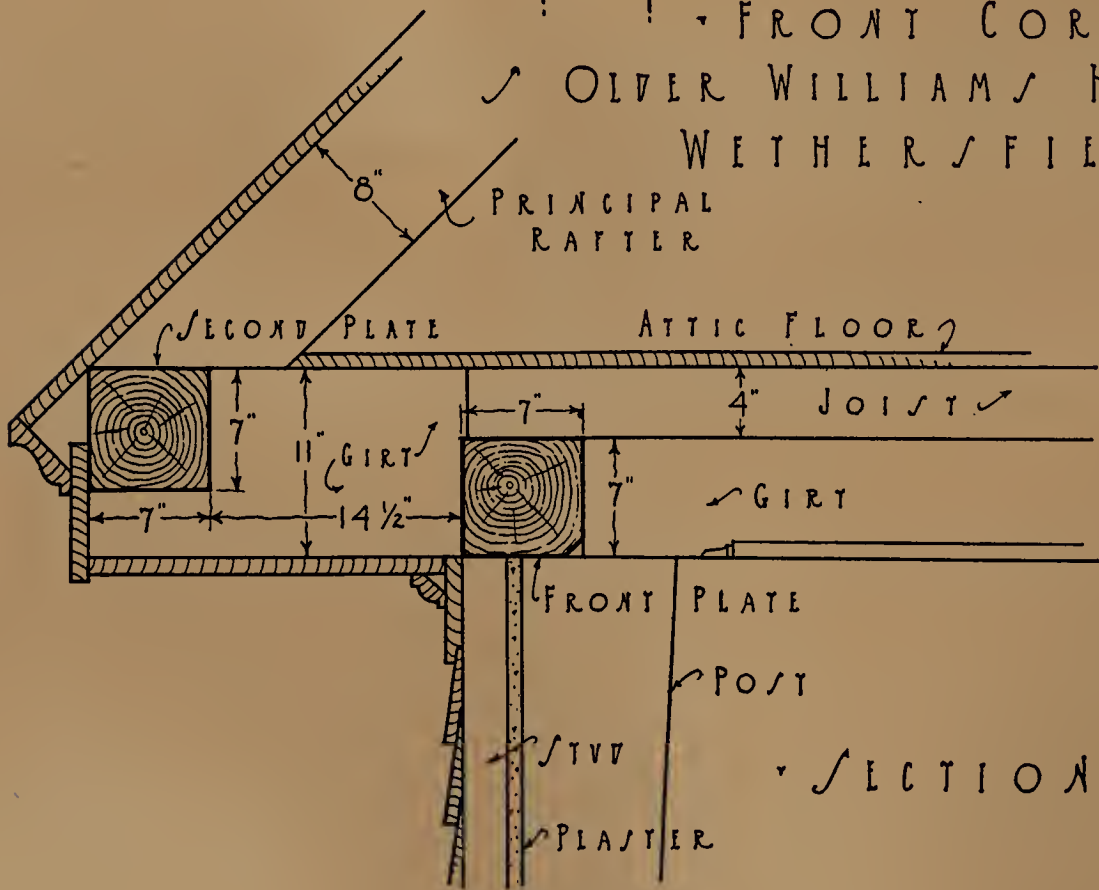
FIGURE 126.

▷ FRONT CORNICE ◁

OLD WILLIAMS HOUSE

WETHERSFIELD

The construction of the front cornice of the older Williams house in Wethersfield (*circa* 1680) is shown in Figure 126. Here is the somewhat common arrangement of two front plates, the first on the house line and the second framed out  $14\frac{1}{2}$  inches beyond it. The girts which carry the second plate are halved on to the first plate where they cross it. A somewhat similar arrangement is to be seen in the main cornice construction of the Deacon Stephen Hotchkiss house in Cheshire (*circa* 1730), illustrated in Figure 127. Here the expedient of cantilevering the second-story girts was likewise resorted to, although in place of a second plate there is only a small 2-by-4-inch purlin. This purlin served as a foundation or nailing piece upon which the cornice was built up, quite as the second plate did in the older Williams house cornice. (Compare Figures 126 and 127.)

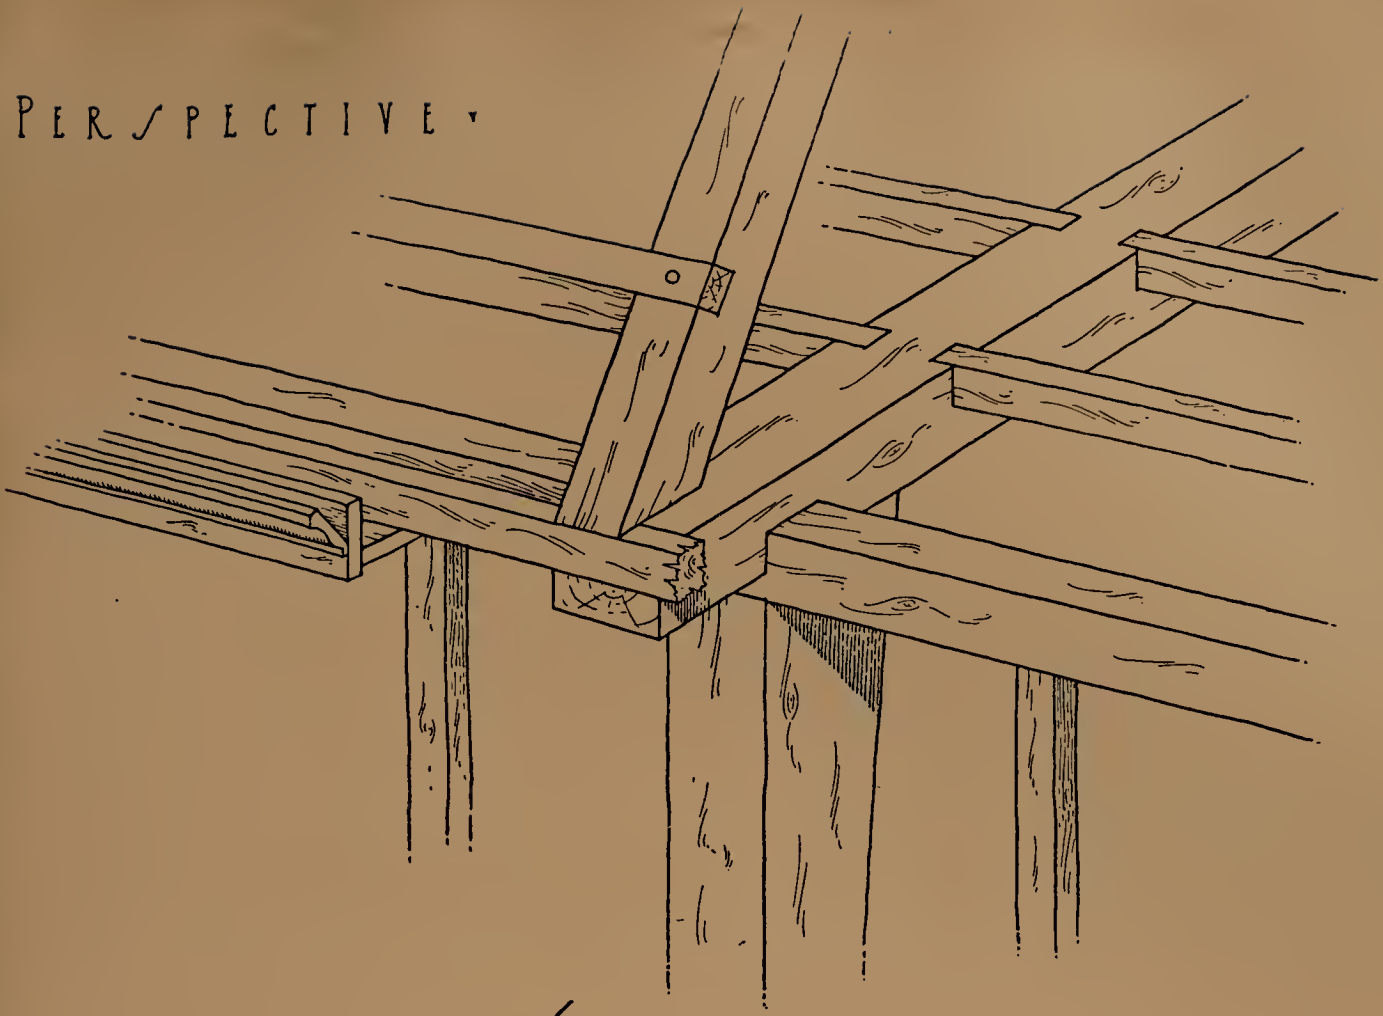
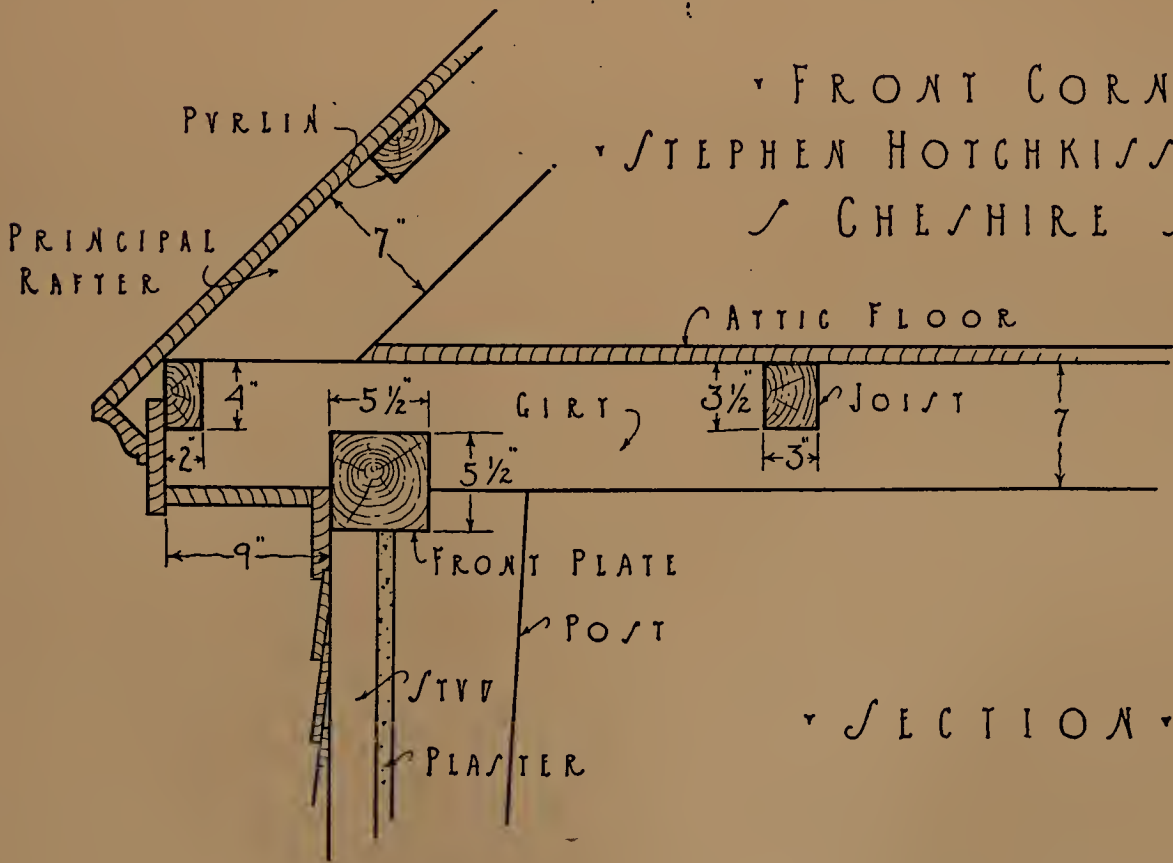
FIGURE 127.

• FRONT CORNICE •  
• STEPHEN HOTCHKISS HOUSE •  
• CHESHIRE •

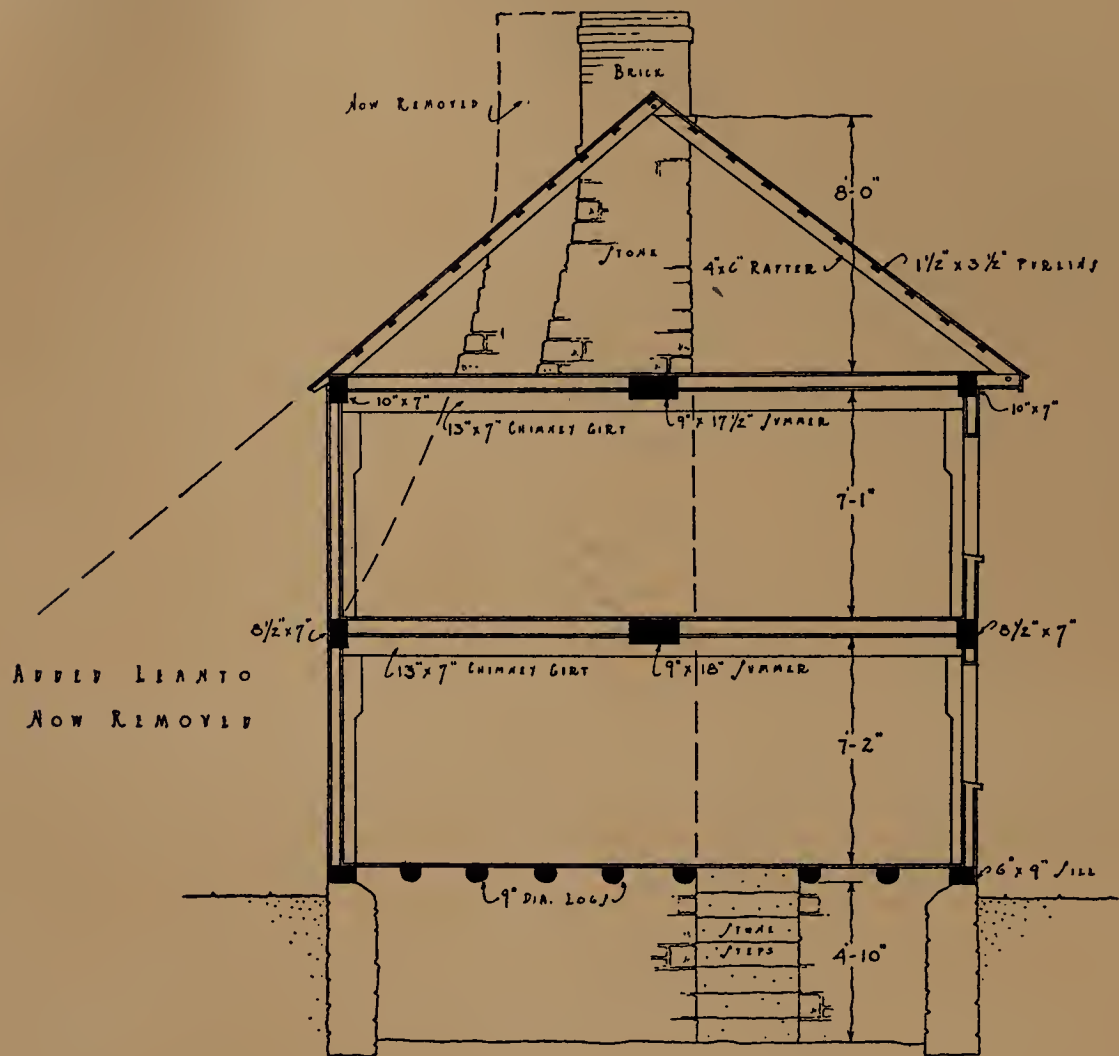
FIGURE 128.

• CROSS SECTION •

✓ ALLEN SMITH HOUSE - MILFORD ✓

halved on to the plate where they cross it. The projection thus gained beyond the house line is simply cased in, and no mouldings are present. In this respect the cornice is similar to that of the Linsley house. The construction of the Smith house cornice is extremely unusual; the writer has seen none other like it in Connecticut. Across the rear of this house, no form of cornice is to be seen; for the rafter feet, the ends of which are simply bevelled off, project beyond the plate on which they rest. (Figure 53.) Another cornice treatment of exceedingly rare occurrence in Connecticut is that consisting of a plastered cove, as in the Pardee house (*circa* 1725) in the town of North Haven. (Plate V.) My

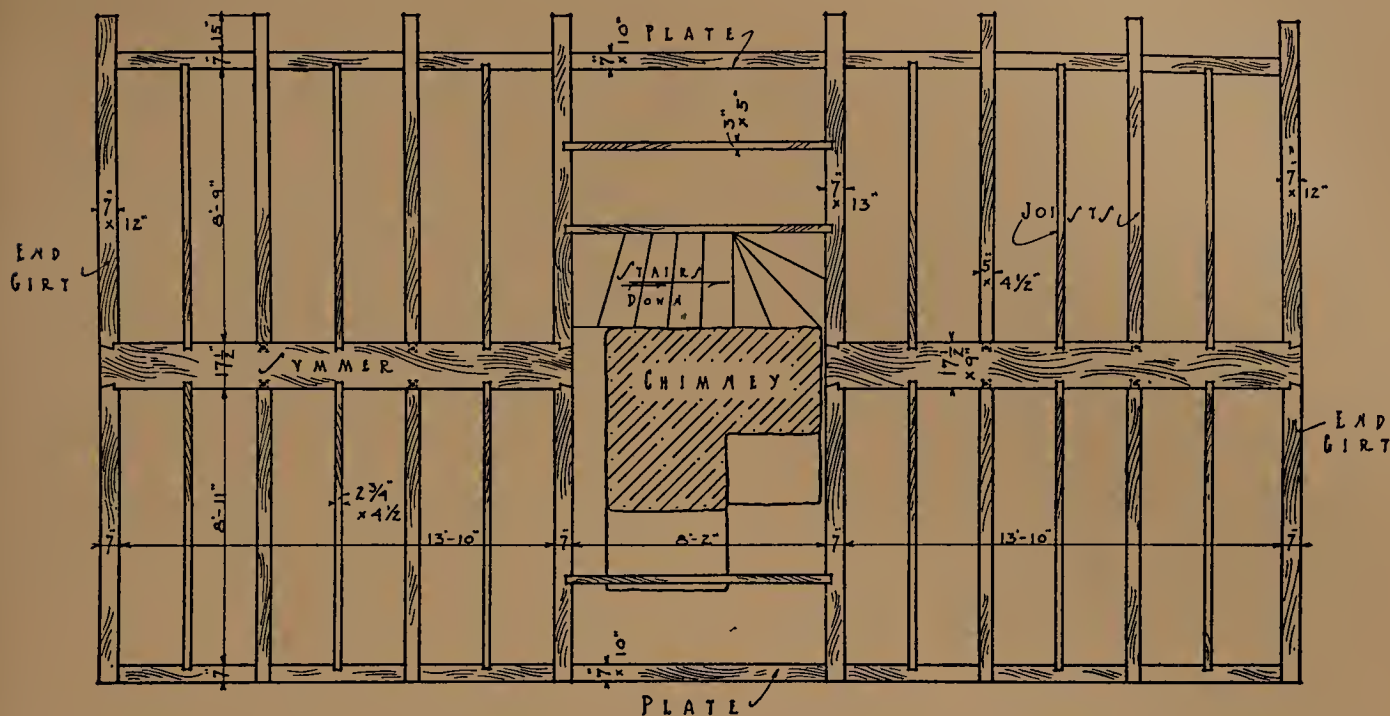
lacking. Both of these cornices, though of decidedly unusual construction, display a common feature in that the front plate is framed out beyond the house line. The purpose of keeping the plate well forward was to provide a foundation upon which the cornice could be built up; and numerous devices of framing were resorted to for this purpose.

• ATTIC FRAMING PLAN •  
 ✓ ALLEN SMITH HOUSE - MILFORD ✓

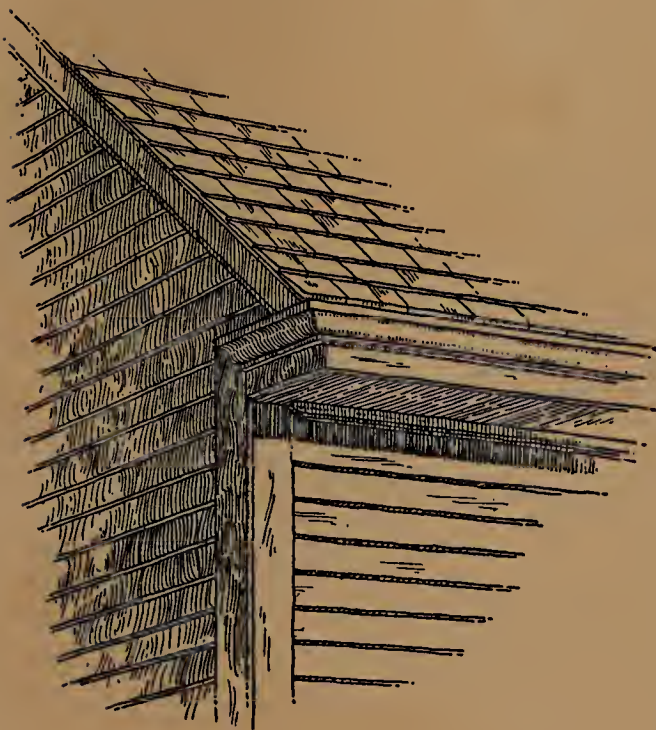
FIGURE 130.

The first cornices in the formation of which mouldings were used were of extreme simplicity. Nothing but straight mouldings were employed, dentil courses and modillion brackets being later introductions. One of the chief characteristics of cornices of this type is the treatment which was nearly always applied to the ends, where they return against the house. This treatment was generally such that the corona or fascia stops flush with the corner boards of the house at either end. (Figure 130.) The projection in front is usually from 10 to 12 inches.

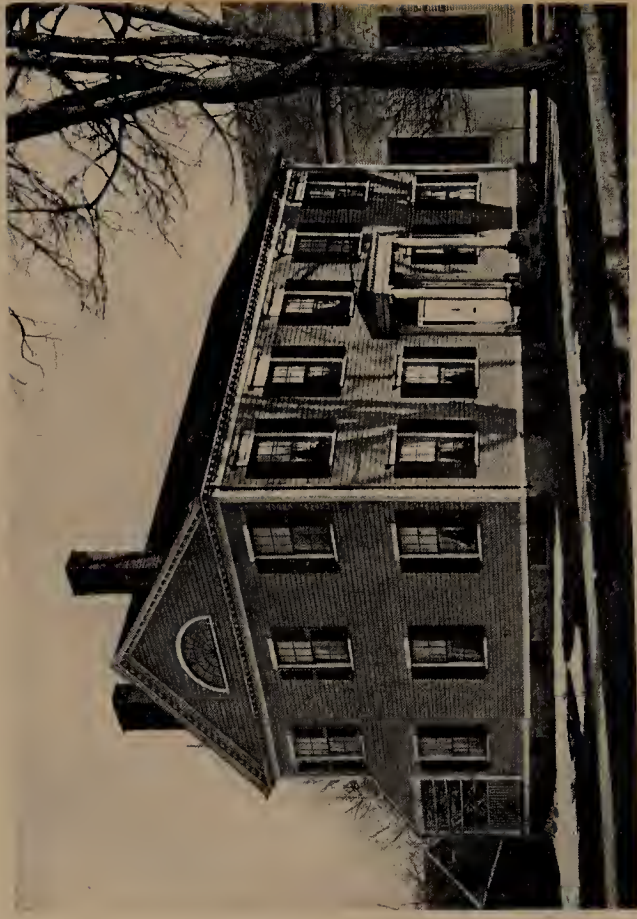
BASSETT HOUSE—HAMDEN

These were present, in a sense, when a pilaster treatment was employed at the corners of the house. Where the cornice was returned across the gable ends of the house, the pediment-like space above it very often contained a window of semielliptical shape, or one of Palladian form, to admit light to the attic. The Bassett house in Hamden (1819) affords a typical example. (Plate XXX.)

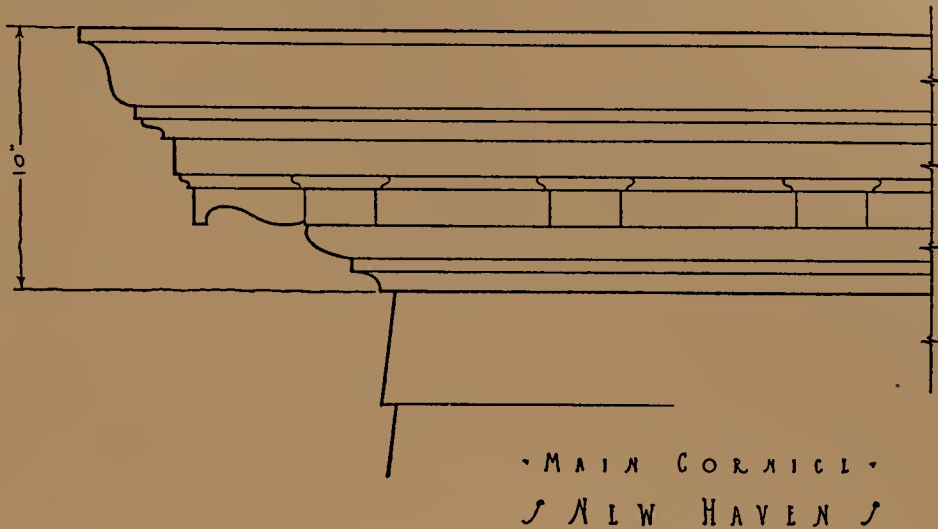
FIGURE 131.

During the latter part of the eighteenth century the main cornice came to be a feature of considerable prominence. An added dentil course, or sometimes two dentil courses, enriched it, as well as additional moulded members; and the introduction of modillion brackets took place. All mouldings entering into the composition became finer in scale, more elegant in profile. A typical cornice of the period is shown in Figure 131.

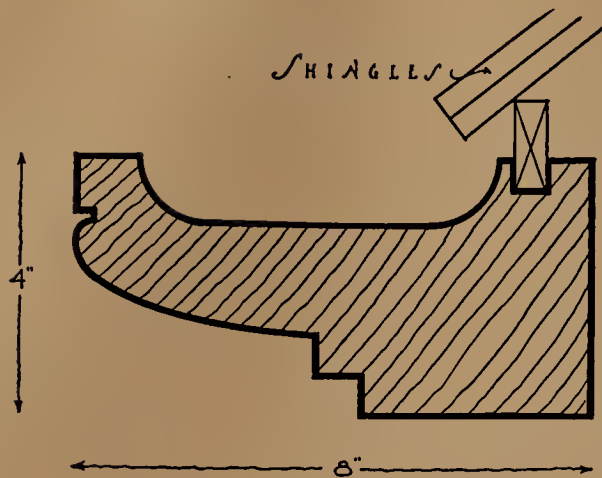
FIGURE 133.

An interesting though not uncommon feature is the formation of a crown moulding and rain-water gutter in combination, from a single solid piece of wood. (Figure 133.) The specimen from which the drawing was made was taken from the cornice of a brick house in the town of North Haven, built in 1756, as figures formed by dark header brick in the gable ends of the structure testify. The wood from which it is made is white cedar; and it became defective only after a hundred and fifty years of faithful service! This represents what is probably the earliest

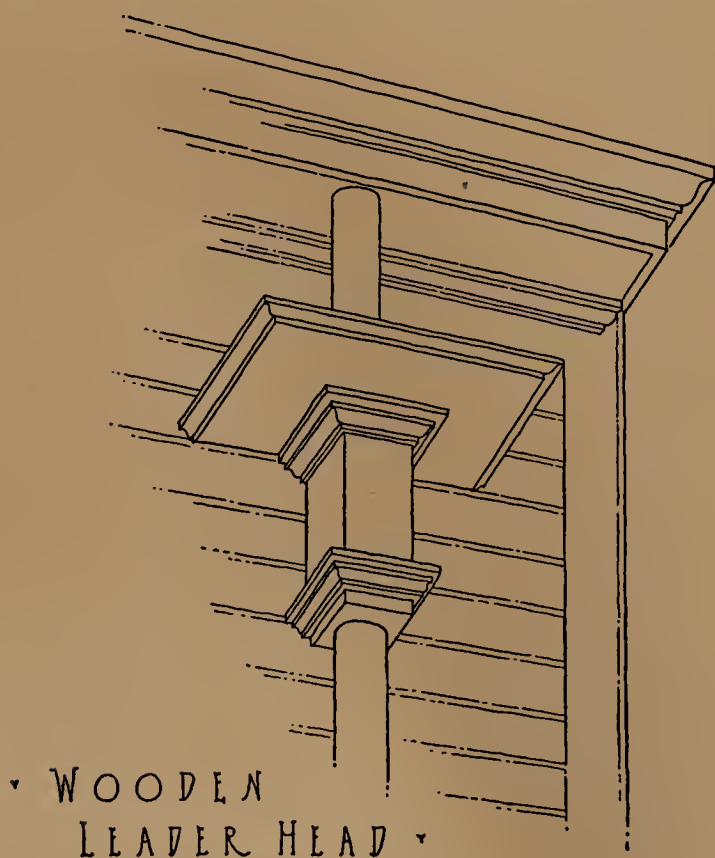
FIGURE 134.

WOODEN  
LEADER HEAD

The leader head, likewise made of wood, and embellished with mouldings, appears to be a feature peculiar to Farmington. (Figure 134.) Its use there occurs with considerable frequency, but it is not usually to be met with outside that locality.

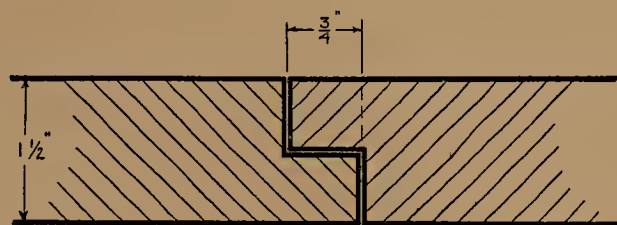
FIGURE 136.

· FLOOR BOARDS ·  
· MOULTHROP HOUSE - EAST HAVEN ·

Double floors seem to be the rule for the first floor, and single ones for the second floor and the attic. Double floors were usually constructed in the following manner: Over the joists was first laid a subfloor of "slit-stuff," or material about a half inch thick, the boards being of irregular width, and often having unsquared edges. Over this, and with the joints running in the same direction, or at right angles to the joists, the finish floor was laid. This top or finish floor was seven-eighths or one inch in thickness, and the boards were of good width—never less than 10 or 12 inches wide, and often more; it is not unusual to find them 18 or 20. These two floors were laid in such a manner that the joints of the top or finish floor were always broken by the boards of the subfloor. This arrangement was made necessary by the fact that the joints of the upper floor were never matched together with a tongue and groove such as is used to-day. Rarely, as in the Evarts Tavern in Northford (*circa* 1710) and the Moulthrop house which stood in East Haven (*circa* 1690), the boards were halved together at the joints. The first floor of the Moulthrop house consisted of a single thickness of oak boarding, 1½ inches thick. (Figure 136.)

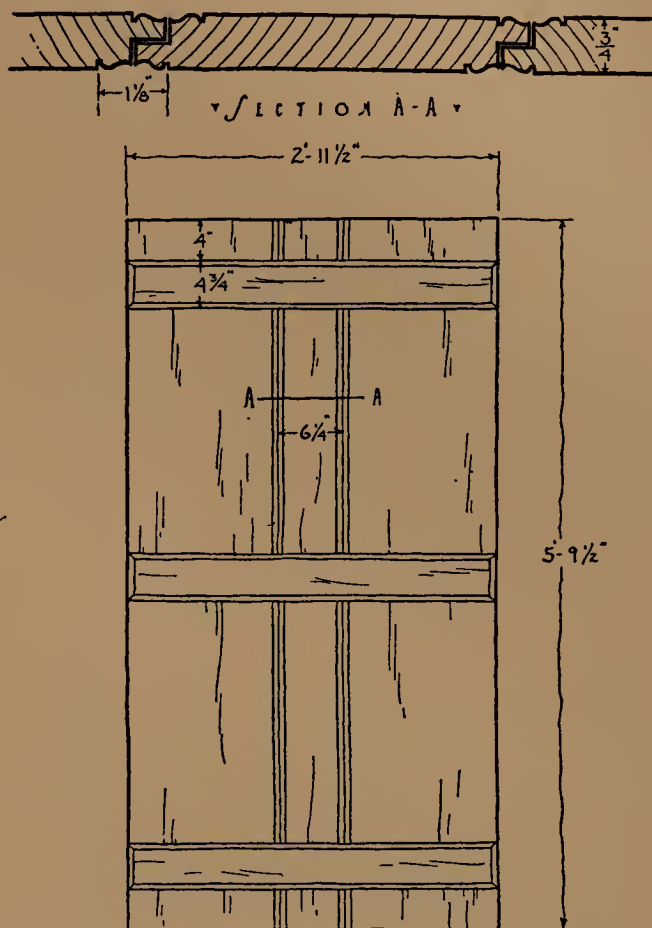
FIGURE 137.

Nearly all the earliest examples of doors existing to-day are of batten construction. A batten door is one made up of a single thickness of boards, held together by horizontal battens or nailing strips on one of its sides. (Figure 137.) The vertical joints of batten doors were nearly always moulded, and the battens themselves had bevelled or beaded edges. The commonest form of vertical joint is that shown in Figure 138, of a door from the Harrison-Linsley house in Branford (1690). A somewhat different form of jointing is shown in Figure 139, of a door in the Loomis house in Windsor (1688). In this example the boards forming the door are halved together and the edges of the joint finished with a quarter-inch bead. Figure 140 shows a very unusual form of vertical joint, in a door from the older Williams house in Wethersfield (*circa* 1680). From the foregoing examples, it will be seen that the boards composing batten doors were of comparatively great width, a door often consisting of but two or three boards. Such doors were built, almost without exception, of white pine.

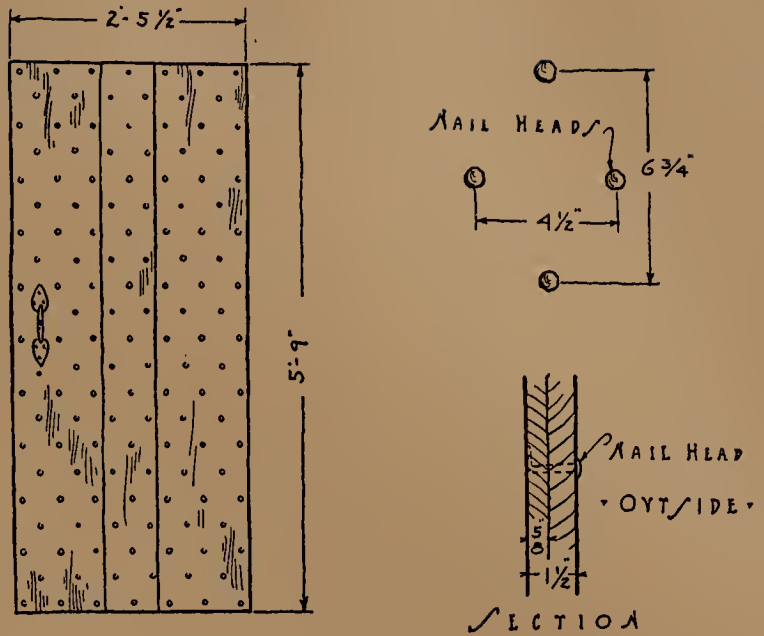
FIGURE 142.

In rare instances the nails which hold the two thicknesses of boards together are so disposed that the nail-heads form a diamond-shaped or diaper pattern on the exterior of the door. (Figure 142.) Such doors are to be seen at the rear of the Jabez Huntington house in Norwich (1719), the Ezra Griswold house in Guilford (*circa* 1760), and the Martin Page house in Branford (*circa* 1750). In each case there is a regular geometric pattern

formed on the exterior of the door by the large heads of the hand-wrought nails used in its construction.
